RESEARCH MEMORANDUM

RESULTS OBTAINED FROM SECOND FLIGHT OF

X-4 AIRPLANE (A.F. No. 46-676)

By Walter C. Williams

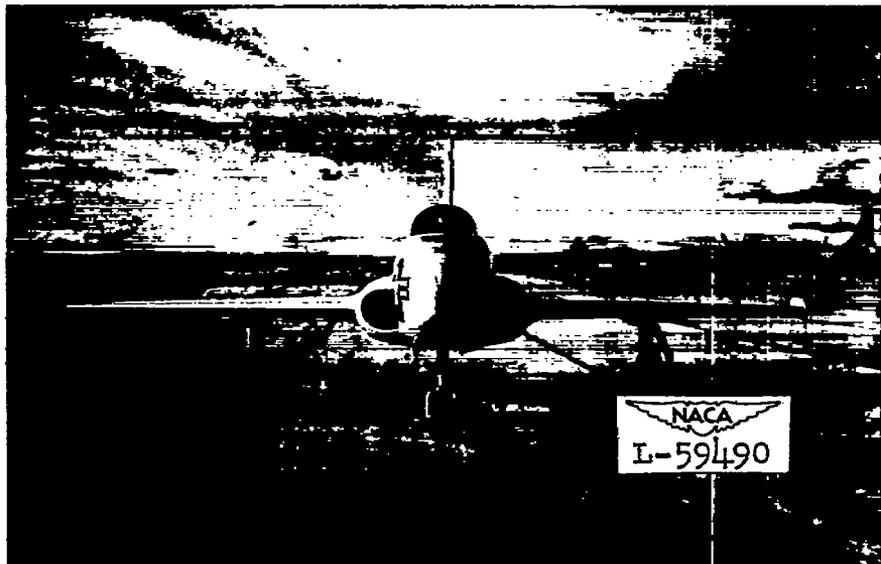
Figure 1.- Photographs of X-4 airplane.

The Northrop X-4 airplane is a semitailless research airplane having a vertical tail but no horizontal tail surfaces. It is powered by two Westinghouse J30-WE-7-9 engines and is designed for flight research in the high-subsonic speed range. Photographs of the airplane are presented in figure 1 and a three-view drawing of the airplane is presented in figure 2. Table I lists the physical characteristics of the airplane.
